To:	Greg Sheppard	Date:	October 31, 2025
c:		Memo No.:	001
From:	Kaya Sokukawa Julie Kostecki Anders Frappell	File:	704-ENG.ROCK03543-01
Subject:	Iqaluit Nukkiksautiit Project 2025 Geotechnical Investigation – Testpit Program Summary

1.0 INTRODUCTION

2.0 2025 TESTPIT CAMPAIGN

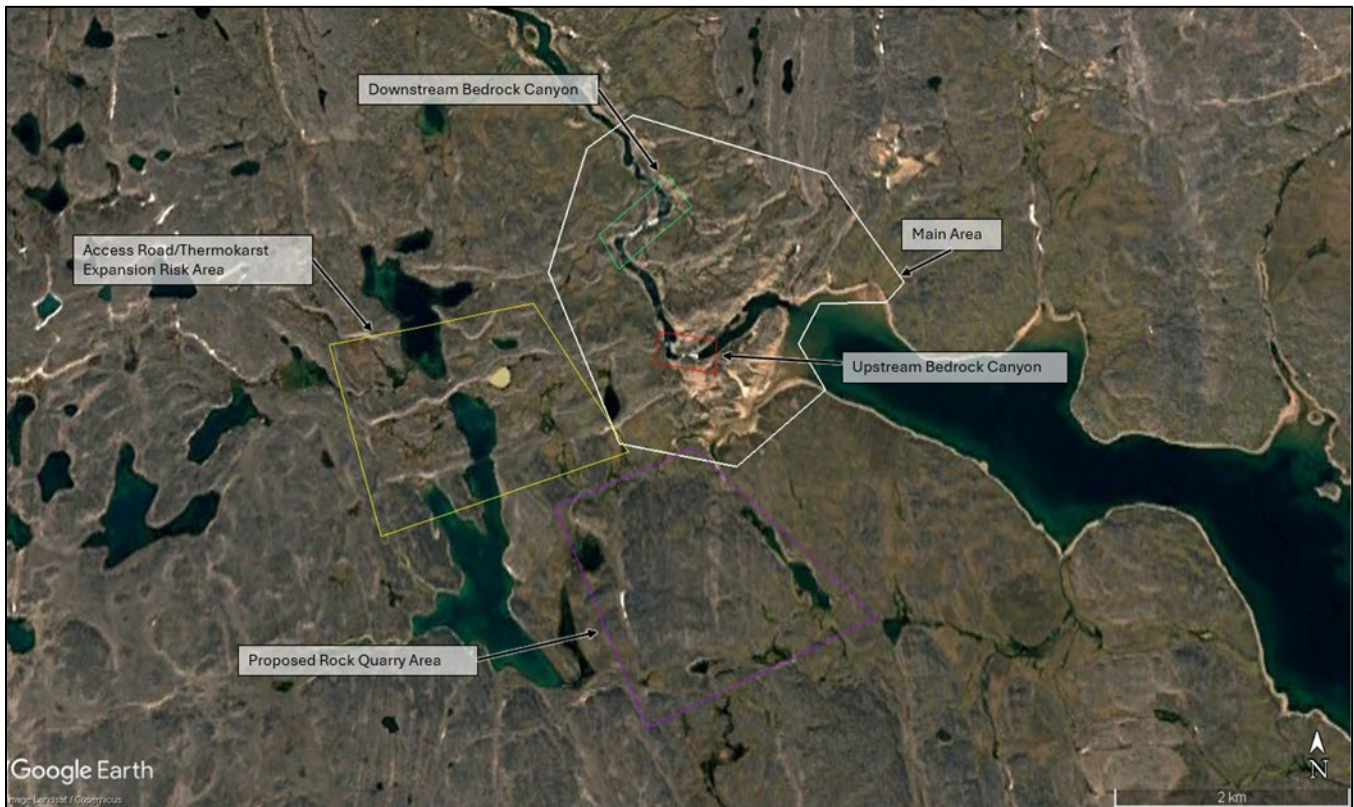
Figure 2-2: Drone Survey Flight Areas

Figure 2-2 illustrates the drone survey locations and Figure 2-3 and Figure 2-4 presents the preliminary drone survey results from the main area and the proposed rock quarry area.

Main area = white; Upstream Bedrock Canyon = red; Downstream Bedrock Canyon = green; Access Road/Thermokarst Expansion Risk Area = yellow; Proposed Rock Quarry Area = purple.

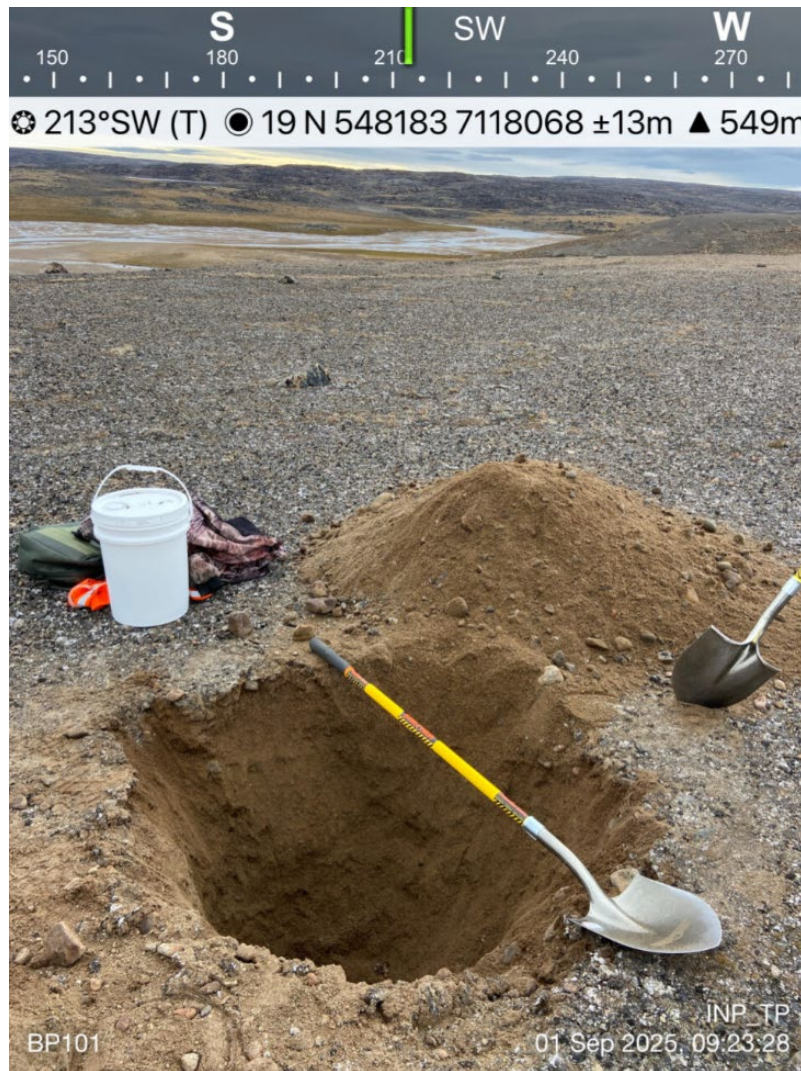
Date		ID	Location			Logged by
01-09-25		BP101	Easting:	548171	Elev. (m):	KS
			Northing:	7118048	UTM:	
Depth (m)		Layer Description			Sample Taken	
From	To	SAND - some gravel, some cobbles, damp, brown; fine to coarse gravel, cobbles up to 200 mm diameter			#	Depth (m)
0	1.2				G1	0.5
End of Testpit at 1.2 m. Testpit terminated at maximum reach of shovel. Active layer temperature: N/A

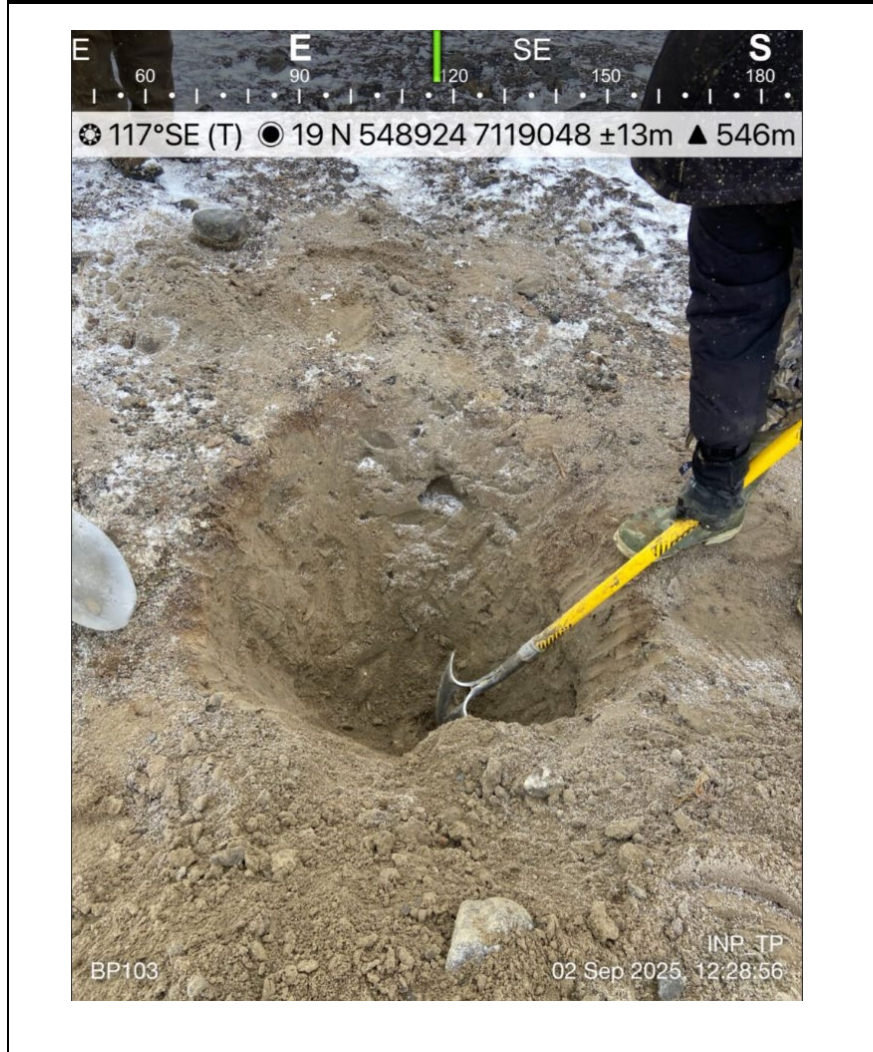
Date		ID	Location			Logged by	
02-09-25		BP103	Easting:	548875	Elev. (m):	KS	
			Northing:	7119008	UTM:		19W
Depth (m)		Layer Description				Sample Taken	
From	To	GRAVELLY SAND - trace to some cobbles, trace fines, dry, brown; fine to coarse sand; fine to coarse gravel; subangular to subrounded gravel; subangular to subrounded cobbles				#	Depth (m)
0	0.6					G1	0.5
End of Testpit at 0.6 m Testpit terminated due to refusal on frozen ground. Active layer temperature: -2.9°C

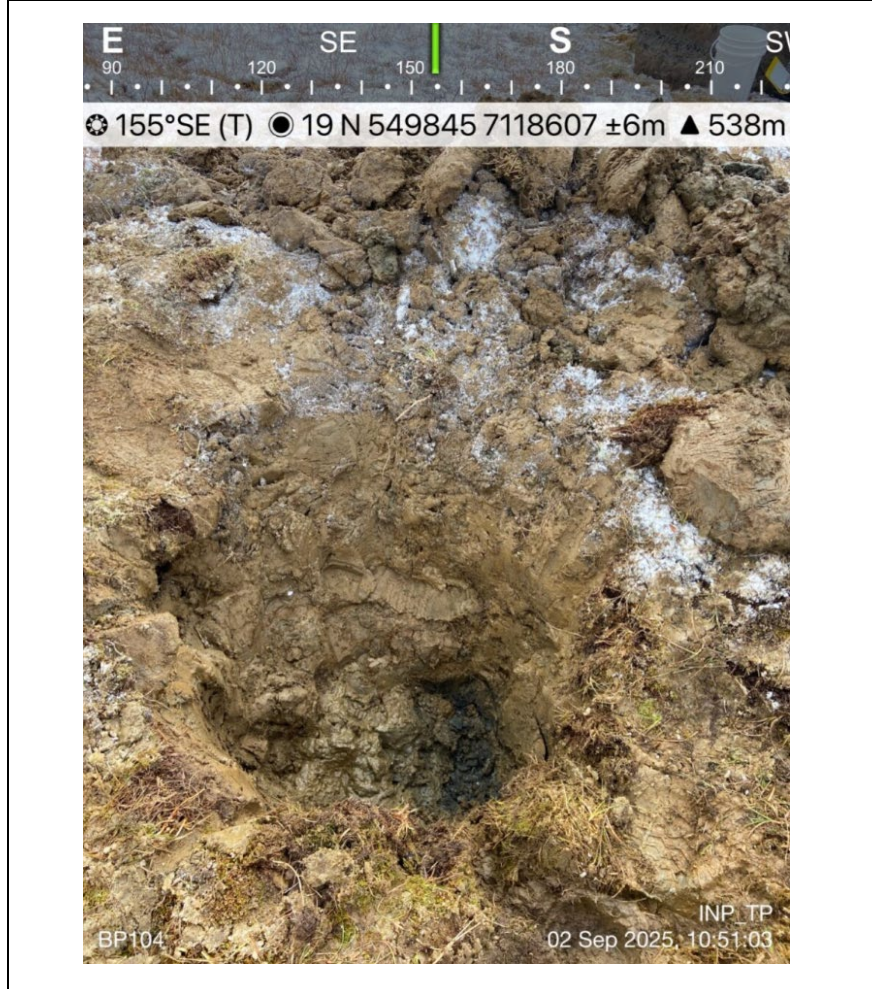
Date		ID	Location			Logged by
02-09-25		BP104	Easting:	550109	Elev. (m):	541
			Northing:	7118498	UTM:	19W
Depth (m)		Layer Description			Sample Taken	
From	To				#	Depth (m)
0	0.1	Topsoil - organics			-	-
0.1	0.7	CLAY - some silt, trace cobbles, trace organics, organic odour, moist, brown; subrounded cobbles			G1	0.3
0.7	0.75	CLAY and SILT - trace sand, trace gravel, compact, ice, grey; fine to coarse sand; fine to coarse gravel; subangular to angular gravel			G2	0.7

End of Testpit at 0.75 m.
 Testpit terminated due to refusal on frozen ground.
 Active layer temperature: -5.4 °C

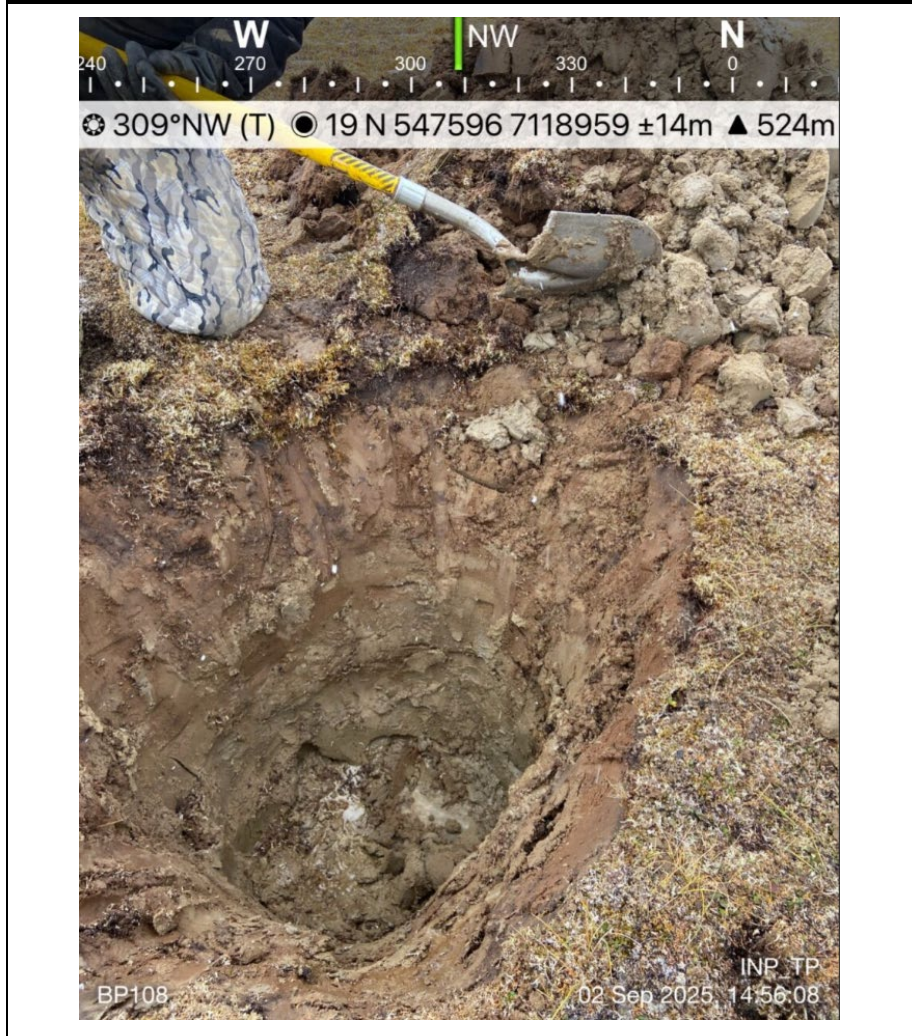
Date		ID	Location			Logged by	
02-09-25		BP108	Easting:	547597	Elev. (m):	520	
			Northing:	7118958	UTM:	19W	
Depth (m)		Layer Description				Sample Taken	
From	To					#	Depth (m)
0	0.1	TOPSOIL - organics, brown				-	-
0.4	0.85	SILTY SAND - trace organics, compact, damp to moist, brown-grey; fine sand				G1	0.8
End of Testpit at 0.85 m. Testpit terminated due to refusal on frozen ground. Active layer temperature: -5.3°C

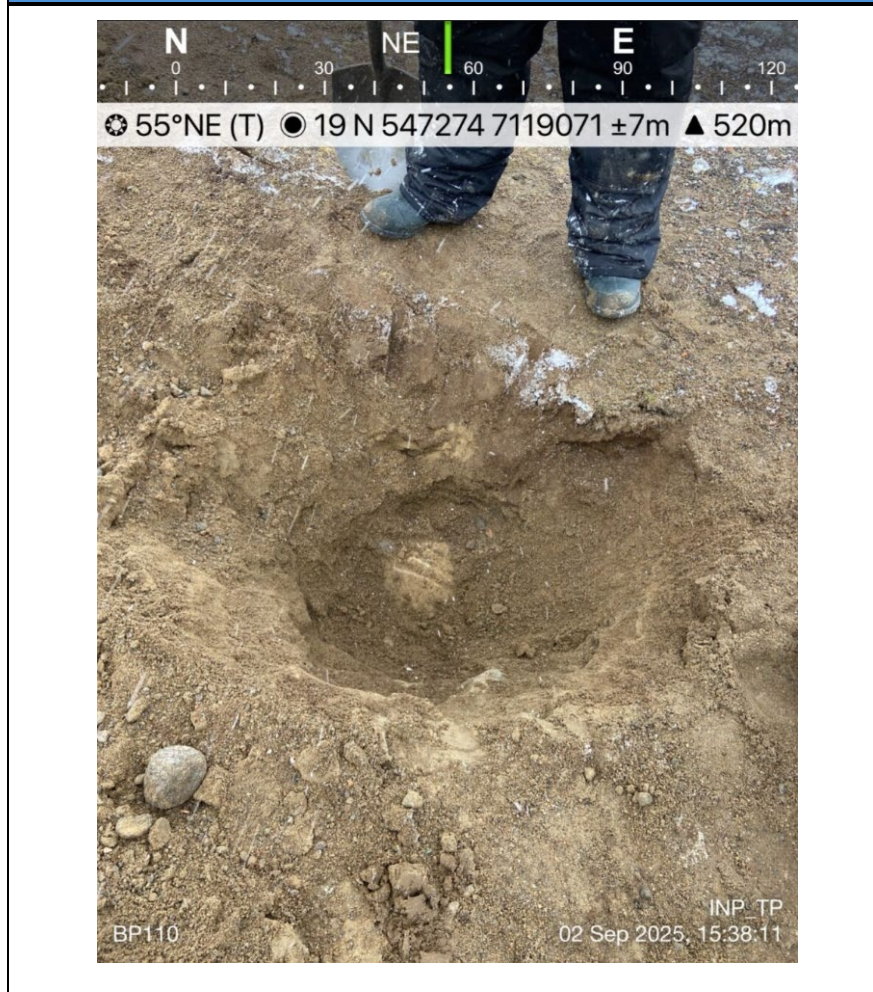
Date		ID	Location			Logged by
2025-09-02		BP110	Easting:	547276	Elev. (m):	524
			Northing:	7119074	UTM:	19W
Depth (m)		Layer Description			Sample Taken	
From	To				#	Depth (m)
0	0.5	SAND - some gravel, trace fines, dry, brown; coarse sand; fine to coarse gravel; angular to subrounded sand; angular to subrounded gravel			G1	0.45
0.5	0.7	BOULDERS - trace sand, trace gravel; subangular to subrounded cobbles; subangular to subrounded boulders; boulders up to 400 mm diameter			-	-
End of Testpit at 0.7 m. Testpit terminated due to refusal on boulders. Active layer temperature: N/A

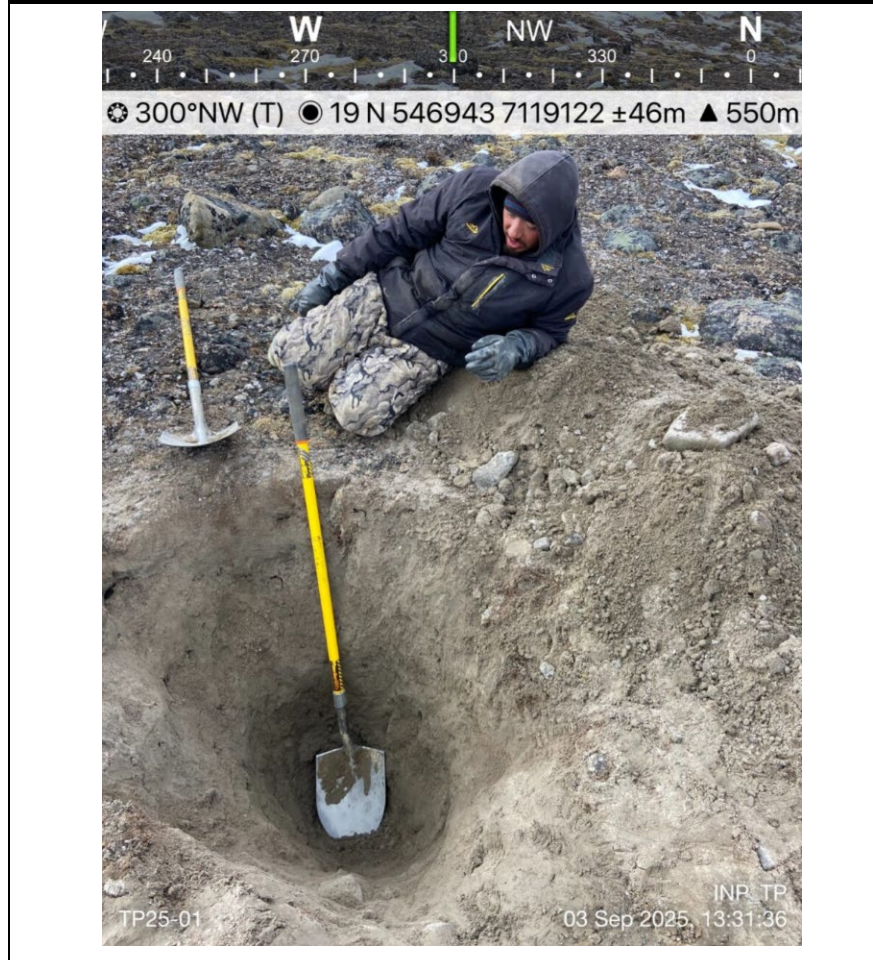
Date		ID	Location			Logged by
2025-09-03		TP25-01	Easting	546953	Elev. (m)	535
			Northing	7119128	UTM	19W
Depth (m)		Layer Description			Sample Taken	
From	To				#	Depth (m)
0	0.05	GRAVEL - cobbly, bouldery; coarse gravel			-	-
0.05	1.2	SILTY SAND - some gravel, trace fines, trace cobbles, trace boulders, dry, brown; fine to coarse sand; angular to subrounded sand; angular to subrounded gravel; subangular to subrounded cobbles; subrounded boulders; boulders up to 400 mm diameter			G1	0.3

End of Testpit at 1.2 m.
 Testpit terminated at maximum reach of shovel.
 Active layer temperature: N/A

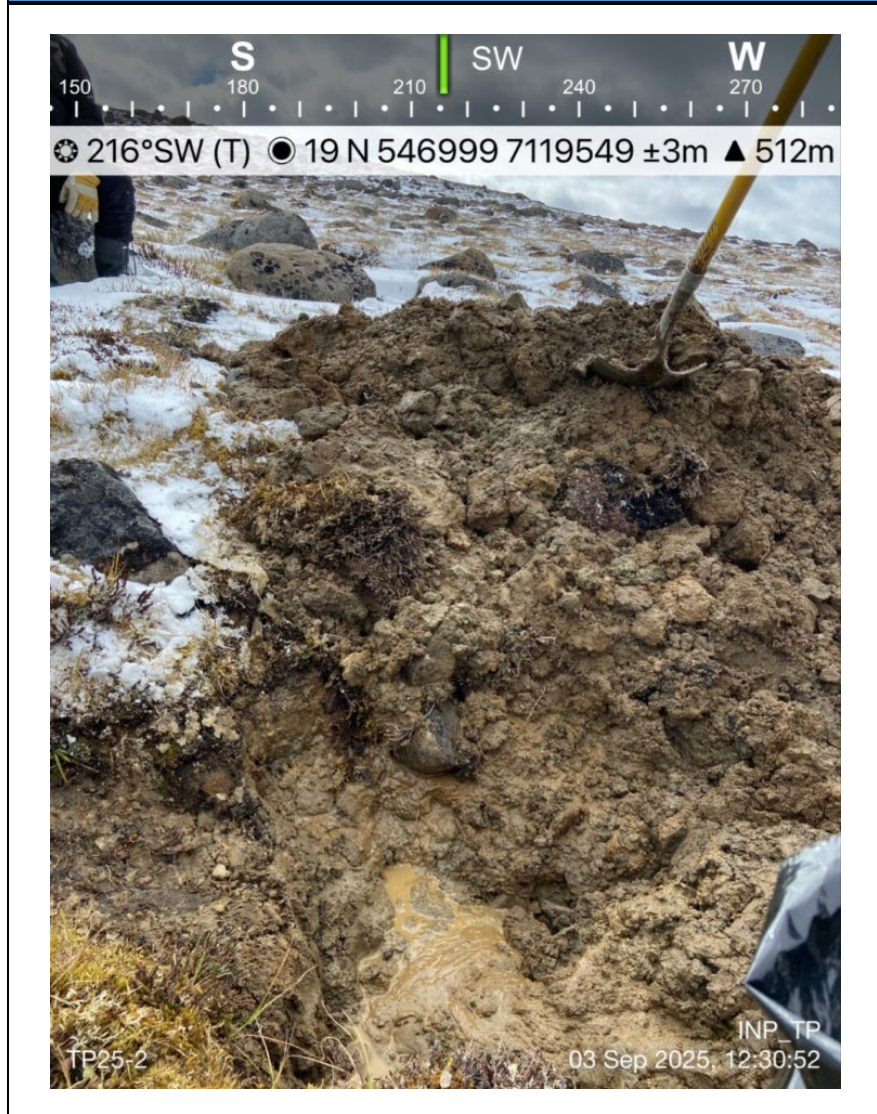
Date		ID	Location			Logged by
2025-09-03		TP25-02	Easting:	546915	Elev. (m):	519
			Northing:	7119550	UTM:	19W
Depth (m)		Layer Description			Sample Taken	
From	To				#	Depth (m)
0	0.1	TOPSOIL - organics			-	-
0.1	0.3	SILTY SAND - wet, brown; fine to medium sand			G1	0.25

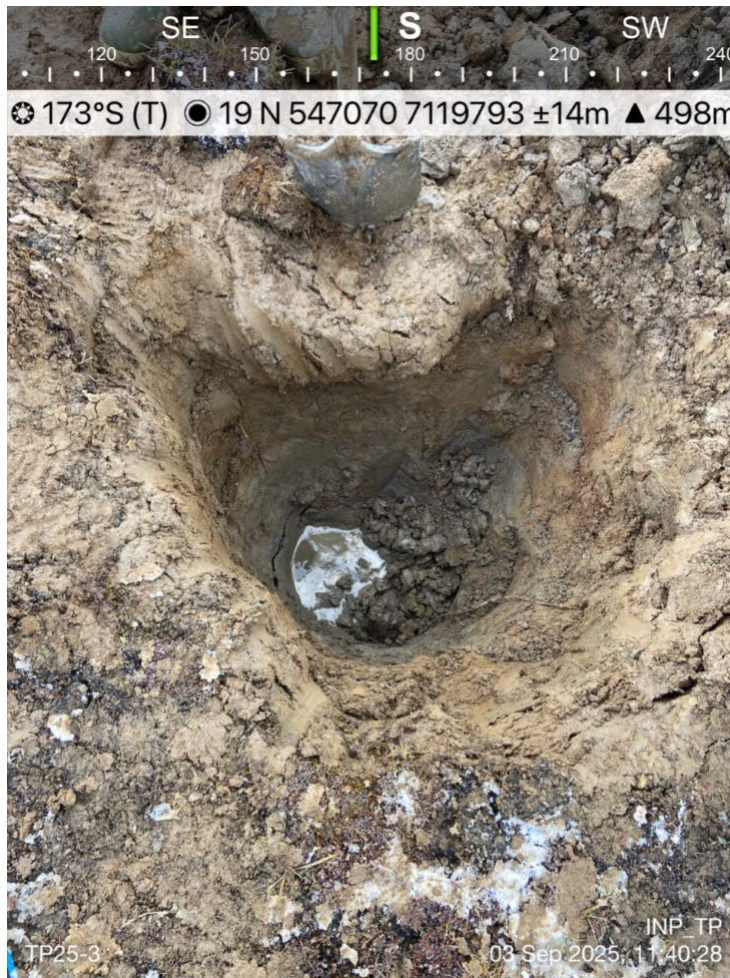
Date		ID	Location			Logged by
2025-09-03		TP25-03	Easting:	546942	Elev. (m):	KS
			Northing:	7119764	UTM:	
Depth (m)		Layer Description			Sample Taken	
From	To				#	Depth (m)
0	0.1	TOPSOIL - organics			-	-
0.1	1.1	SILTY SANDY CLAY - moist, low plastic, brown-red; fine to medium sand			G1	0.4
1.1	1.2	SAND - brown, wet; medium to coarse			-	-
End of Testpit at 1.2 m. Testpit terminated due to excess water/sloughing. Active layer temperature: N/A

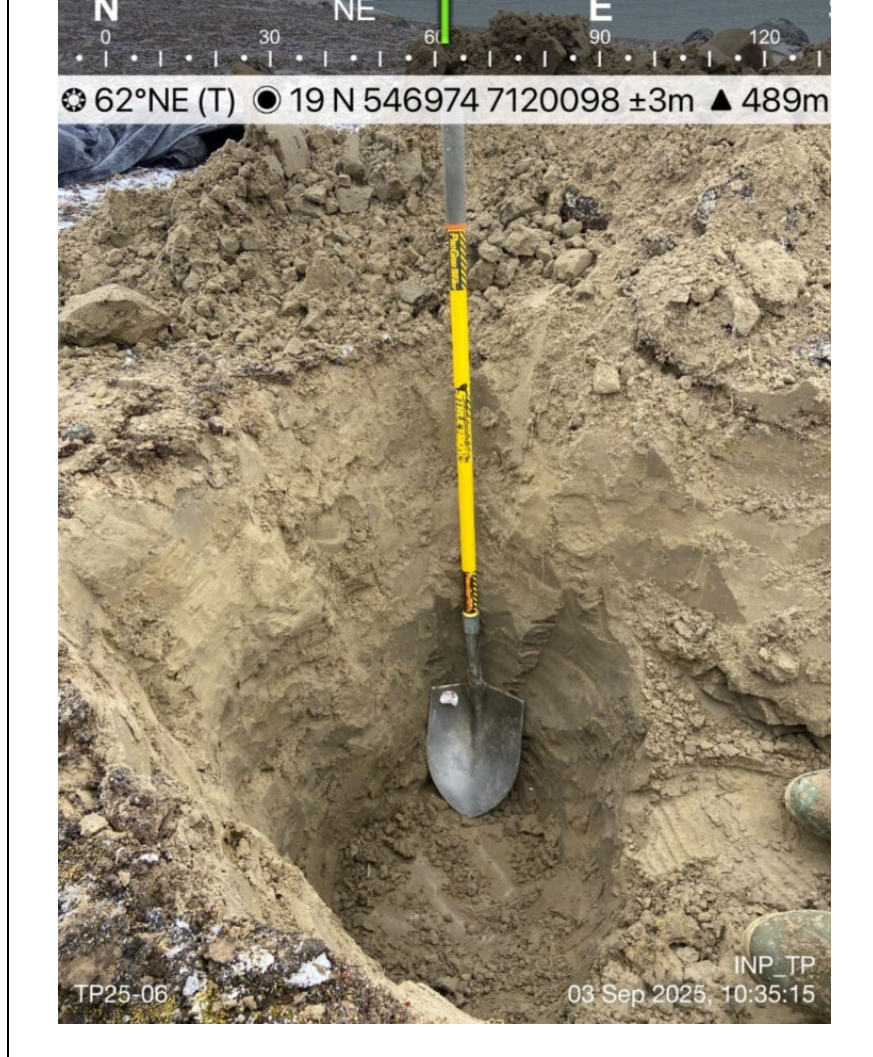
Date		ID	Location			Logged by
2025-09-03		TP25-06	Easting:	546979	Elev. (m):	KS
			Northing:	7120096	UTM:	
Depth (m)		Layer Description			Sample Taken	
From	To				#	Depth (m)
0	0.1	TOPSOIL - organics			-	-
0.1	1.06	SILT - some sand, trace clay, damp, brown; fine sand			G1	0.3

End of Testpit at 1.06 m.
 Testpit terminated due to refusal on frozen ground.
 Active layer temperature: -4.5 °C

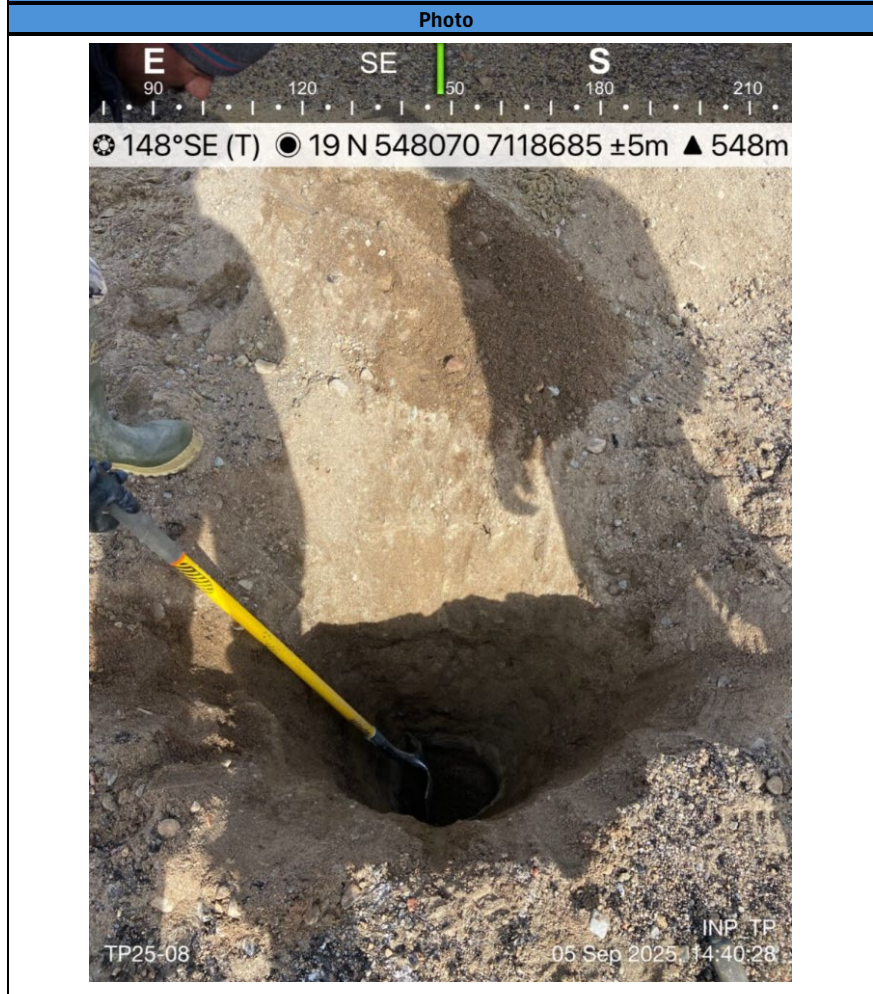
Date		ID	Location			Logged by
2025-09-03		TP25-08	Easting:	548070	Elev. (m):	KS
			Northing:	7118685	UTM:	
Depth (m)		Layer Description			Sample Taken	
From	To				#	Depth (m)
0	0.55	SAND - some gravel, trace fines, dry to damp, brown; fine to coarse sand; fine to coarse gravel; sub angular to subrounded sand; subangular to subrounded gravel			G1	0.4
0.55	0.9	SAND - trace fines, dry to damp, brown; fine to coarse sand			-	-
0.9	1.2	SILT - trace clay, dry, grey			G2	1
End of Testpit at 1.2 m. Testpit terminated at maximum reach of shovel. Active layer temperature: N/A

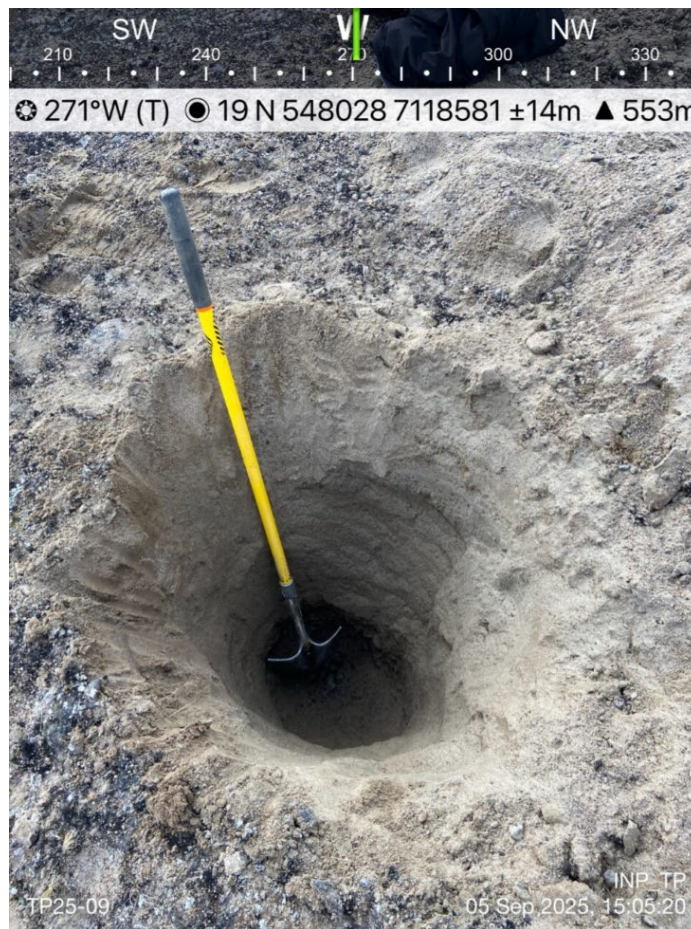
Date		ID	Location			Logged by
2025-09-05		TP25-09	Easting:	548029	Elev. (m):	545
			Northing:	7118580	UTM:	19W
Depth (m)		Layer Description			Sample Taken	
From	To				#	Depth (m)
0	0.85	SAND - some gravel, some fines, dry, brown; fine to coarse sand; fine gravel; subangular to subrounded sand; subangular to subrounded gravel			G1	0.3
0.85	1.2	GRAVEL - some sand, trace fines, trace cobbles, dry, brown; fine to coarse gravel; fine to coarse sand; subrounded gravel; subrounded sand; cobbles up to 80 mm diameter			G2	1

End of Testpit at 1.2 m.
 Testpit terminated at maximum reach of shovel.
 Active layer temperature: N/A
